Why Do PVC & CPVC Pipes Occasionally Fail?

By Dr. Duane Priddy, Plastic Failure Labs, Midland, MI

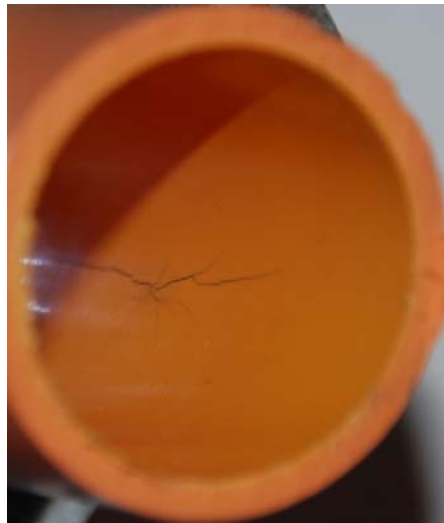
Plastic Failure Labs is an independent forensic laboratory. We have been conducting forensic failure analyses of plastic parts for several years. We have carried out hundreds of forensic failure analysis investigations of CPVC and PVC pipes and fittings at the request of insurance companies, installers, pipe manufacturers, general contractors, condominium associations, and private owners. We have found that the overwhelming/most common cause of failure is improper installation practices. Sometimes installation errors result in contamination, although these two issues are not always related. The combination of pipes under stress plus the exposure to incompatible materials, can lead to environmental stress cracking failure or ESC. This is especially the case with CPVC sprinkler system piping if not adequately flushed as recommended in NFPA 13 to remove debris and trace chemicals. If CPVC fire sprinkler systems are not flushed, trace chemicals remain trapped inside for periods of time and may become absorbed into the CPVC. CPVC is a very ductile material. However, the combination of prolonged high stress and absorption of certain hydrocarbon contaminants may cause it to weaken and develop stress-cracks (Figure 1).

Figure 1. Formation of a stress-crack on the inside of a CPVC fire sprinkler pipe at a point where a tight-fitting clamp was used.

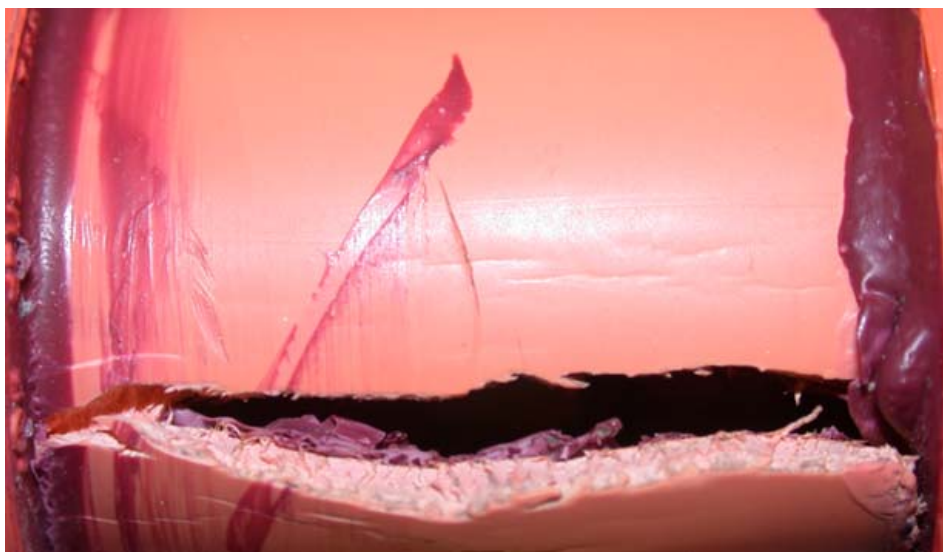
Excessive cement use: An installation problem that we occasionally see is the use of excessive cement. The solvents in the cement themselves are readily absorbed into CPVC and PVC; i.e., they readily are absorbed into the wall of the pipe and inside fitting socket resulting in solvation/softening of the material. Figure 2 shows a short piece of pipe with a fitting on each end having excess cement puddled inside the short piece of pipe. The solvents in the cement absorbed into the pipe wall resulting in softening of the pipe wall to the point that the pipe wall became swollen/softened and no longer had sufficient strength to hold water pressure resulting in blowout.

Figure 2. Puddling of excess cement inside of fitting ran into adjacent pipe resulting in softening and blowout of the pipe wall.

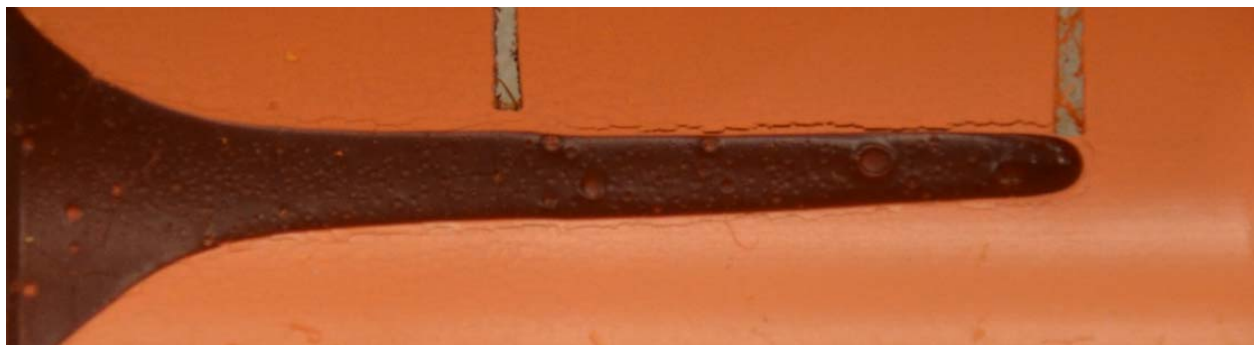
Figure 4. Cement dribble on inside of CPVC pipe with ESC cracks found around the periphery of the dribble.

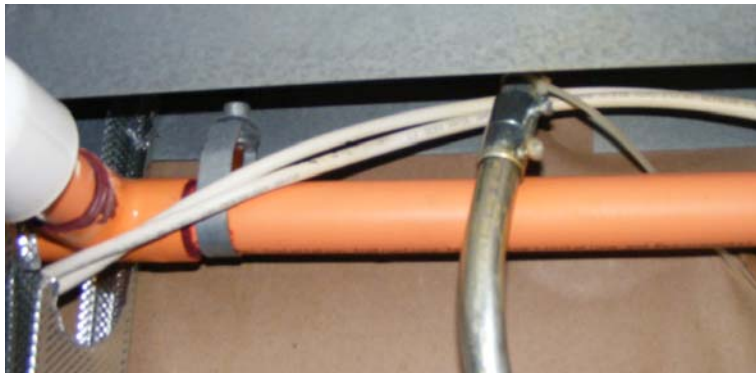
Incorrect Clamps and Contact with Conduit/Wire: Another very common cause of occasional failure is the use of the wrong type of support which places stress on the pipe. Also bending conduits around PVC or CPVC pipe can place high localized stress on the PVC/CPVC pipes in contact with the conduit. Some electrical wires, especially computer cables, should not be allowed to come into contact with PVC or CPVC pipes because the outer flexible sheath may contain plasticizers which can migrate into the pipe resulting in weakening and failure of the pipe. Figure 6 shows a photograph of a CPVC fire sprinkler pipe installation revealing contact of the pipe with electrical wire and a conduit – both should be avoided.

Figure 6. Picture of installation showing direct contact of conduit and electrical wires with CPVC pipe.

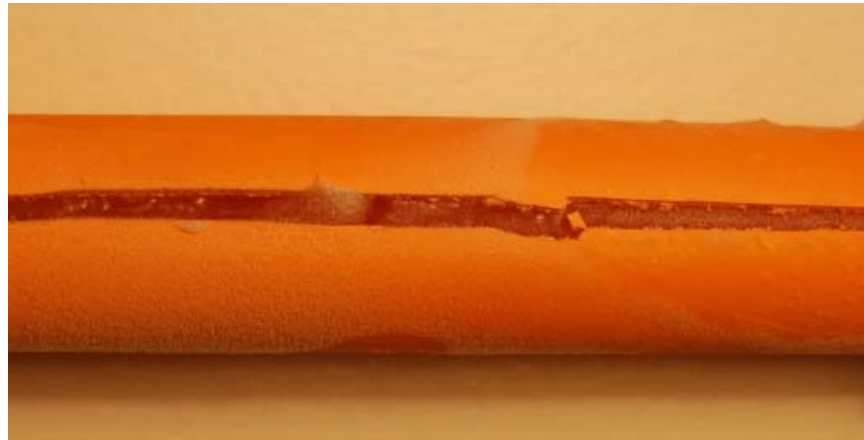
Diagnoses of the failure of CPVC pipes due to freezing is a challenge. If CPVC pipes break due to radial expansion of ice inside a CPVC pipe (Figure 7), diagnoses is quite simple because the pipe generally expands causing the wall thickness to decrease and go out of spec (Figure 8). However, researchers at the University of Illinois found that generally when pipes freeze, radial expansion is constrained by the pipe wall forcing the ice to expand longitudinally. The linear expansion of the ice causes a pressure build-up between the ice plug and the outlet or inlet valve. It is the high pressure that causes the failure. This discovery led them to receive several patents (US 5,730,168, US 5,785,072, and US 5,785,073) on devices that protect pipes from failure due to freezing.

Figure 7. Picture of frozen CPVC pipe.

the only antifreeze solution recognized as acceptable by the NFPA (NFPA 13:Section 7.6.2). Again, a highly experienced engineering professional should design the piping system to ensure that appropriate freeze protection is incorporated into the system.

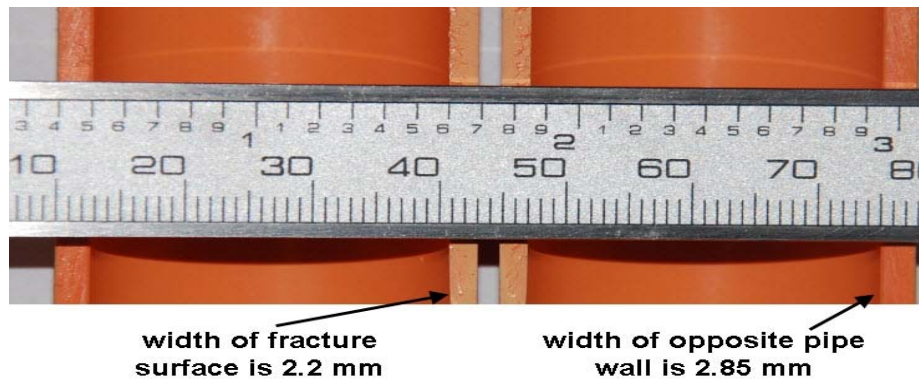
The frozen pipe shown in Figure 7 was thawed and then cut longitudinally in half by sawing through the pipe wall 180 degrees away from the fracture surface. Simply measuring the thickness of the pipe wall at the fracture surface and comparing the wall thickness 180 degrees opposite, reveals a large difference (Figure 8). The difference is caused by the slow tensile stretch and yielding/necking at the point of fracture. The yielding/necking at the point of fracture results in the thinning of the material at the point of fracture.

Figure 8. Wall thickness at fracture is significantly smaller than 180° opposite.

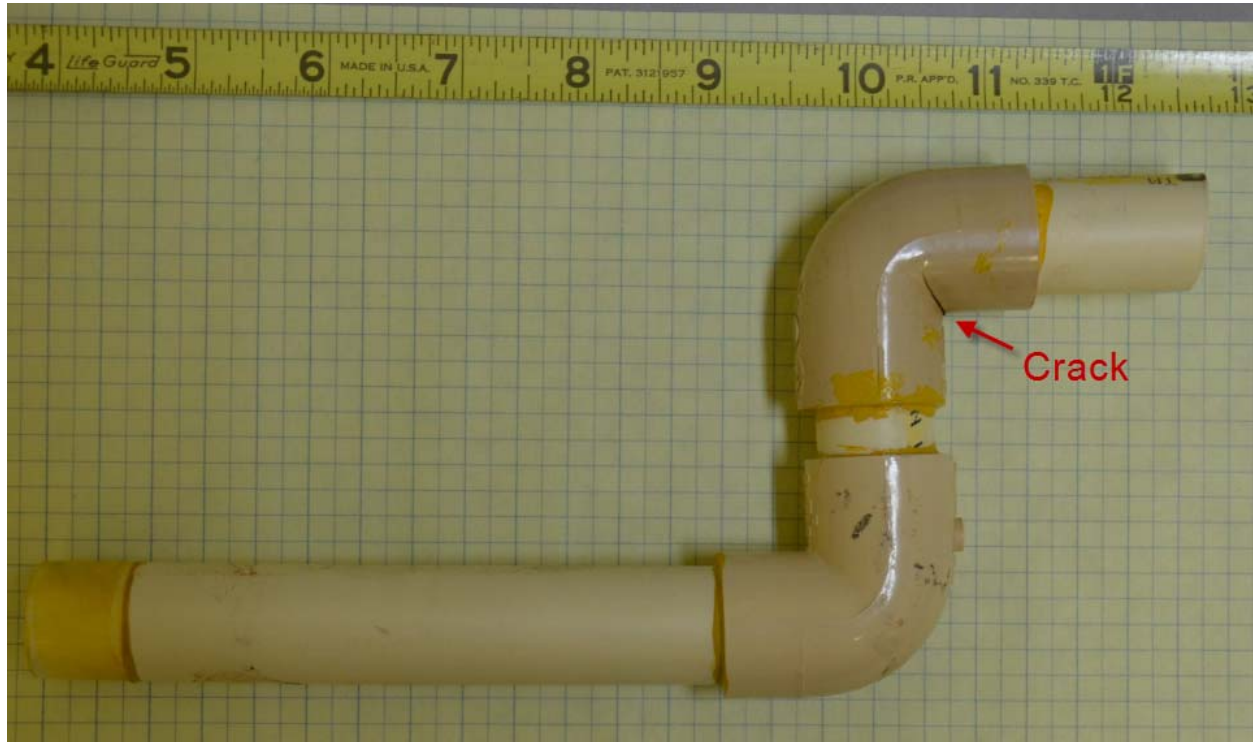
Pipe alignment: Pipes must be installed without excessive bending deflection stresses on the pipe. Pipe manufacturer's instructions should be followed regarding the maximum allowable bending deflections of their pipes. Excessive bending deflection may lead to failure of both the pipe and the fittings to which the pipes are connected. Elbow and Tee fittings are subject to creep failure in the crotch (Figure 9) if pipes are not installed in 90 degree alignment.

Figure 9. Pipes installed out of alignment placing high stress on the crotch of an elbow resulting in creep failure.

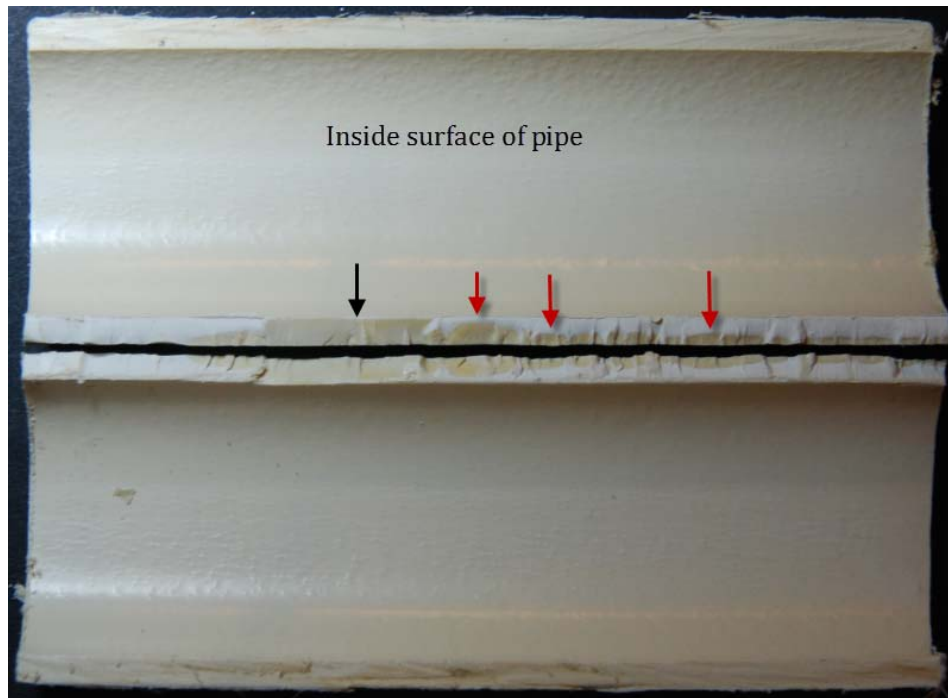
Figure 14. Close up view of the fracture surfaces showing distinctive thumbnail chemical penetration patterns from the outside wall of the pipe. Black arrow points to leak location and red arrows show thumbnail penetration zones that form as chemicals migrate into the outside wall of the pipe.

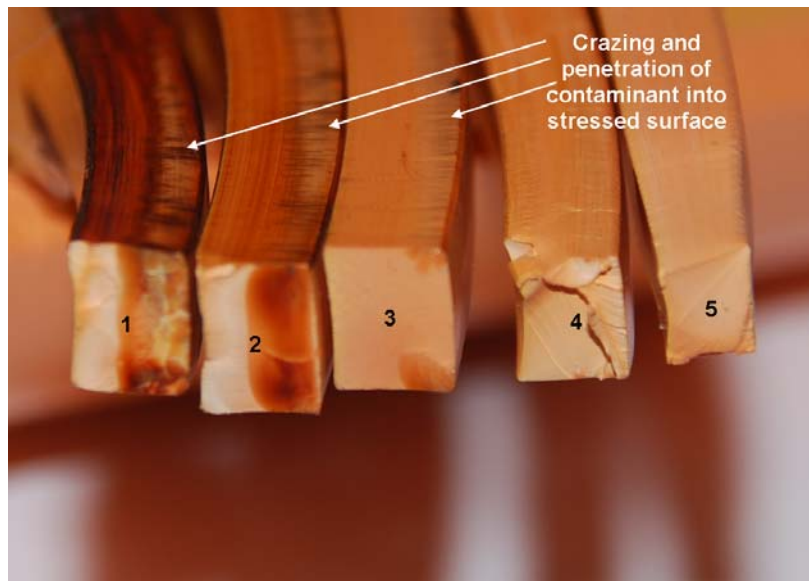
Some anti-MIC or antimicrobial linings in steel pipes may contain traces of water extractable chemicals that are not compatible with CPVC. Figure 15 shows the effects of water containing various trace levels of an amine (didecylmethylamine, a contaminant often found in ABF-2) and its quaternary ammonium salt form on CPVC test specimens. Notice the extensive crazing and discoloration of the treated test specimens down as low as 0.001% or 10 ppm of amine leads to chemical attack and weakening of CPVC. Currently there are some MIC inhibitor products that have been approved by Lubrizol as being compatible with their Balzmaster CPVC pipes. The list continues to grow as additional products are tested and approved. Since it is not a static list, we suggest that you refer to the Lubrizol website for the most updated list (see <http://www.lubrizol.com/BuildingSolutions/ChemicalCompatibility.html>).

Figure 15. The effects (discoloration and crazing) of trace levels of chemical contaminants from ABF-II (amine and ammonium salt) on stressed CPVC test specimens. 1=0.1% amine in water, 2=0.01% amine in water, 3= 0.001% amine in water, 4=0.1% ammonium salt in water, 5=control.

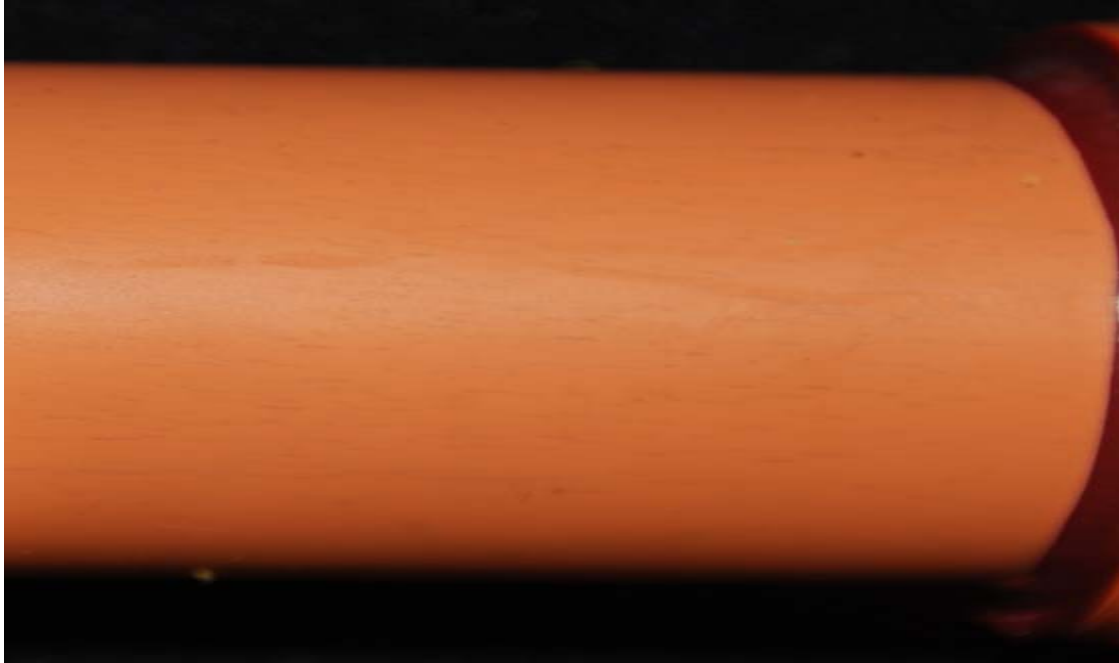
Figure 17. Extensive surface crazing of outside pipe wall.
